The Plan to Save Fallingwater

This breathtaking house designed by Frank Lloyd Wright was in danger of collapse until an engineering firm found a way to stop it from falling down

A firsthand account
by renowned engineer

Robert Silman

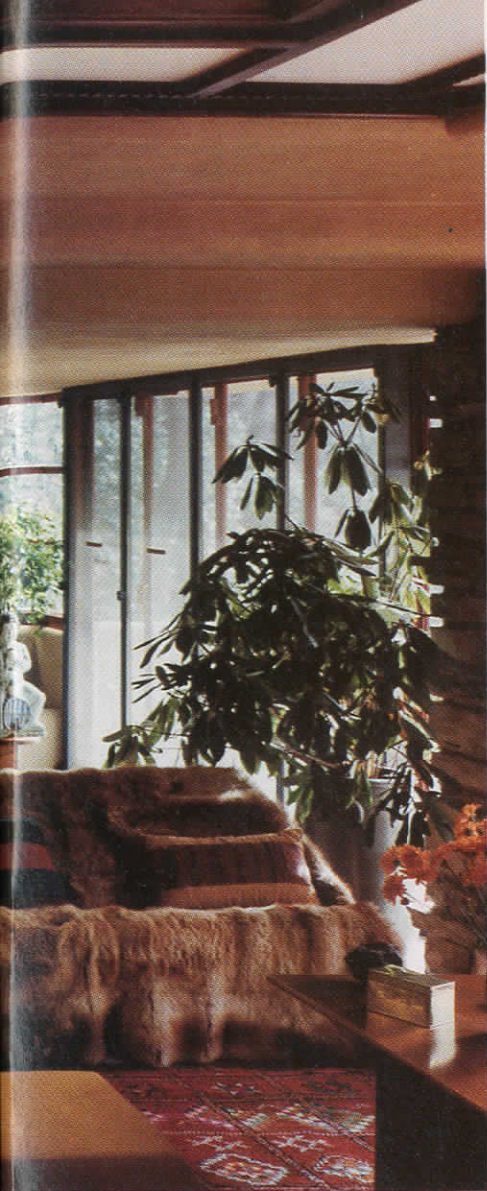
INTERIOR VIEW of Fallingwater's living room shows the stone floor that rests on the house's cantilever beams. The windows at the south end of the room are divided by four steel mullions that help support the weight of the second floor.

out than the first floor does, extending an additional 1.83 meters (six feet) southward [see left illustration below]. Four T-shaped window mullions rise from the south edge of the living room to the terrace above. At first glance these steel mullions appear to be merely decorative, but we would eventually learn that they, too, play a key role in Fallingwater's structure.

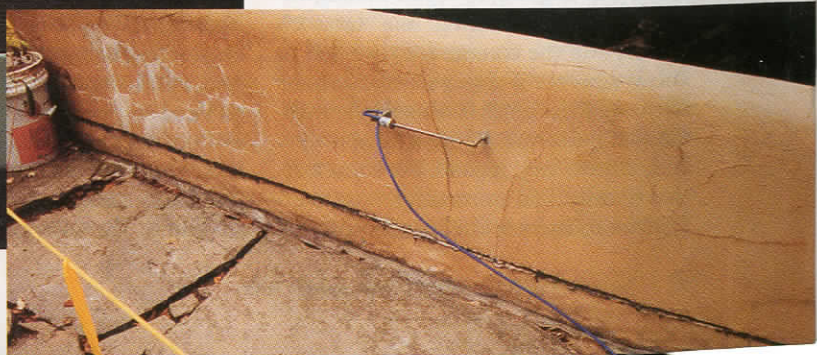
CRACKS IN THE PARAPETS of the second-floor terrace appeared as a result of the stresses in the concrete structure (left). Electronic monitors attached to the parapets measured changes in the width of the cracks over 18 months and confirmed that they were growing (below).

The problem became even more apparent after the completion of the second floor. Soon after workers removed the formwork from the concrete of the master bedroom terrace, two cracks appeared in the terrace's parapets. In 1937 Metzger-Richardson conducted load tests of the structure and calculated that the stresses in the cantilever beams were near or even exceeded the margins of safety. The engineering firm recommended placing permanent props in the streambed to support the first floor and thus reduce the length of the cantilevers. But Wright stubbornly defend-

Our first question was, "Have the deflections stopped, or are they still growing?" Using an instrument called a water level, we took height readings at more than 30 locations and attempted to relate them to the survey readings done earlier. Our measurements showed that the edge of the west terrace had sagged by as much as 146 millimeters and the edge of the east terrace by as much as 184 millimeters. The deflection of the south end of the master bedroom terrace was about 114 millimeters. We then installed electronic monitors to measure very small movements of the terraces and changes in the width of the cracks in the terrace's parapets. The results over more than one and a half years, corrected for daily and seasonal temperature variations, confirmed that the cracks were still growing and the terraces sagging ever lower.

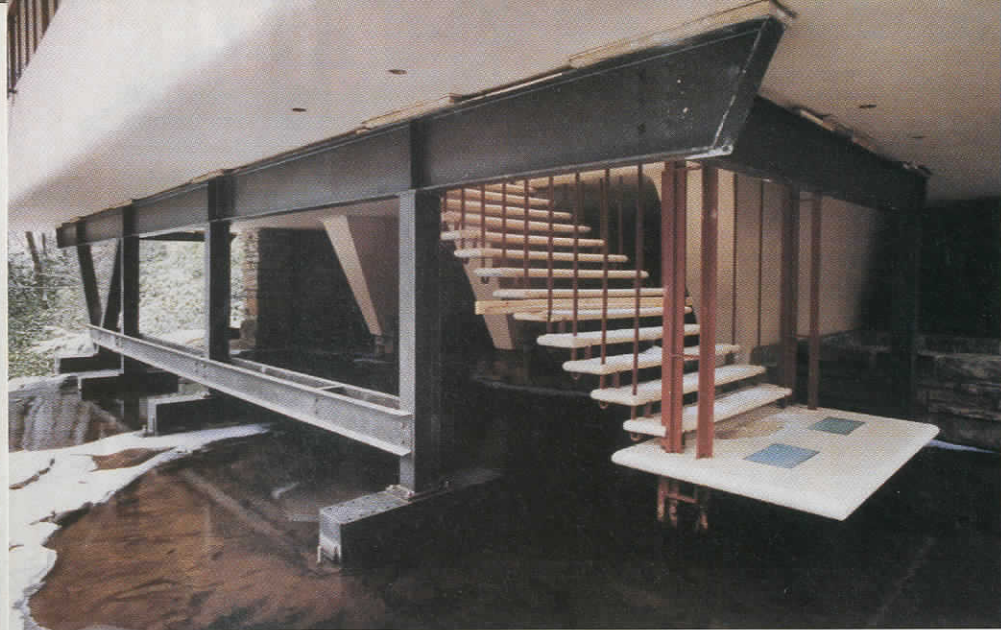
TEMPORARY SHORING installed in 1997 ensures that Fallingwater will not collapse before permanent repairs can be made to the structure. A line of steel columns and girders rising from the streambed of Bear Run supports the concrete underside of the house's cantilevered first floor.

Thus, in 1997 workers installed a relatively unobtrusive line of steel columns and girders rising from the streambed of Bear Run to the underside of the first floor [see illustration at left]. In addition, they also shored a portion of the streambed itself, the jutting sandstone ledge over which Bear Run cascades. The ledge was braced with pipe struts in a cave behind the waterfall. The temporary shoring, which ensures the safety of the tourists who continue to visit the house, will remain in place until the permanent repairs are completed.

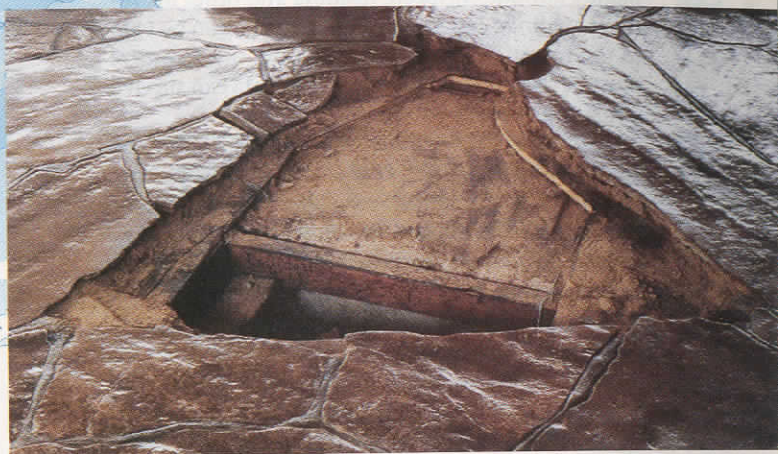
PLANNED REPAIRS involve relieving the stresses in the cantilever beams through the creative use of post-tensioning. Steel cables will be rigged on both sides of each beam, anchored in concrete blocks attached to the beam's ends (left). The cables will then be tightened from the outside using a hydraulic jack. The tension in the cables will exert a positive bending moment on the beam, counteracting the negative moment caused by cantilever action. A section of one cantilever beam beneath the living room floor (below) has already been exposed to allow engineers to inspect it.

The repair scheme calls for the stone floor of the living room to be removed temporarily. This will allow access to the three main cantilever beams from above. At the south end of each beam—the end jutting over Bear Run—we will attach concrete blocks to both sides of the beam [see left illustration on opposite page]. Into each block we will insert a hollow duct with an inside diameter of 6.35 millimeters. The ducts will run alongside the beams, angling upward and extending through holes drilled in the concrete joists. We will also drill holes in the exterior of the south parapet so that high-strength post-tensioning cable can be threaded through the ducts.

The cables will be anchored at the north end of each beam. At the south end, we will tighten the cables from the outside using a hydraulic jack. The tightened cables will be rigged in such a way that they exert a positive bending moment on each cantilever beam. This positive moment will essentially coun-

teract the negative moment caused by cantilever action, lowering the tension in the upper part of the beam and the compression in the lower part. We will also connect post-tensioning cables to the parapet edge beams in the east and west terraces to relieve the stresses in those beams. On the second floor, we plan to reinforce the overstressed concrete joist just above the steel window mullions, either by bolting steel channels to each side of the joist or by bonding carbon-fiber plates to it. At the conclusion of the project, we will patch and paint the holes in the parapet, replace the stone floor and remove the temporary shoring.
